## **Hydrolytic Stability of Polyurethane-Coated Fabrics Used for Collapsible Fuel Storage Containers**

**by James M. Sloan**

**ARL-TR-6949**

**June 2014**

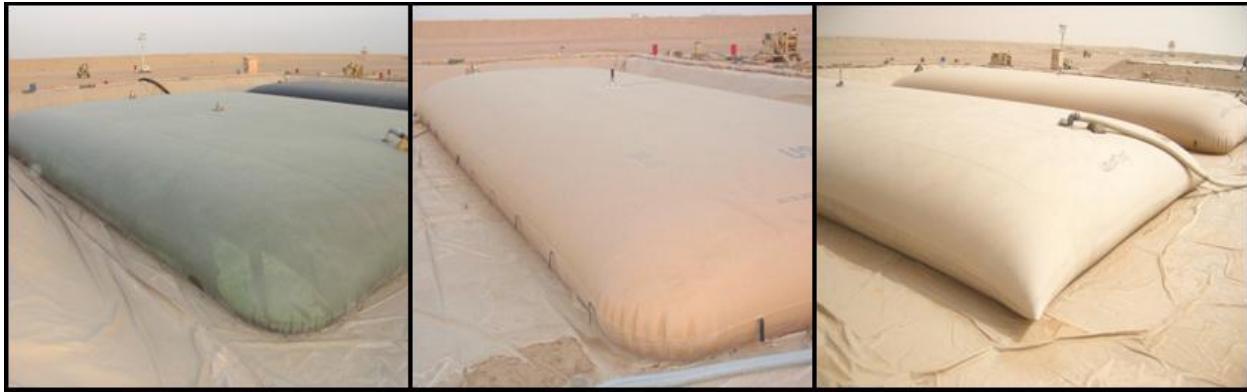
Figure 1. Examples of 50,000-gal fabric-reinforced elastomer tanks.

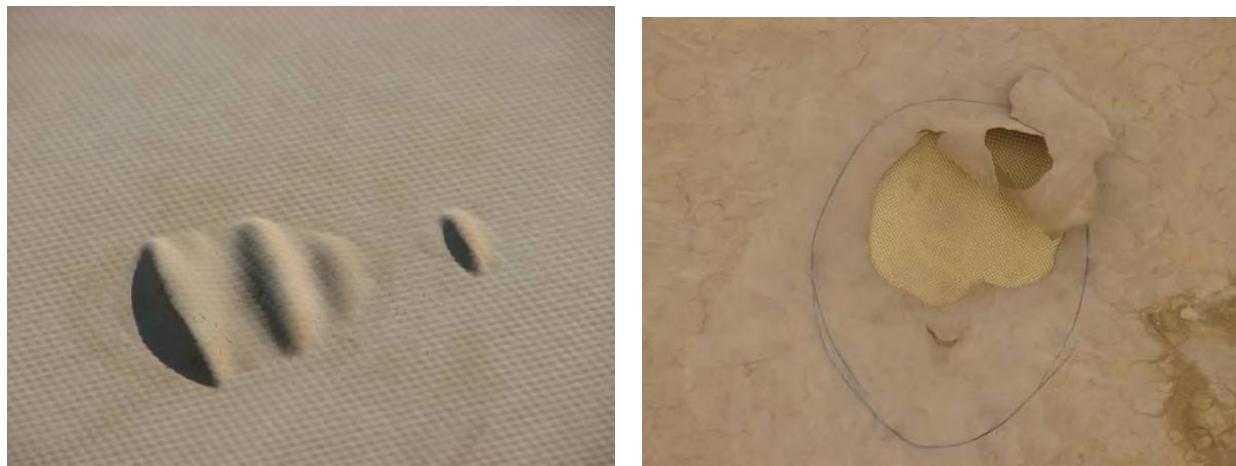
Figure 2. Fabric blistering due to hydrolysis.

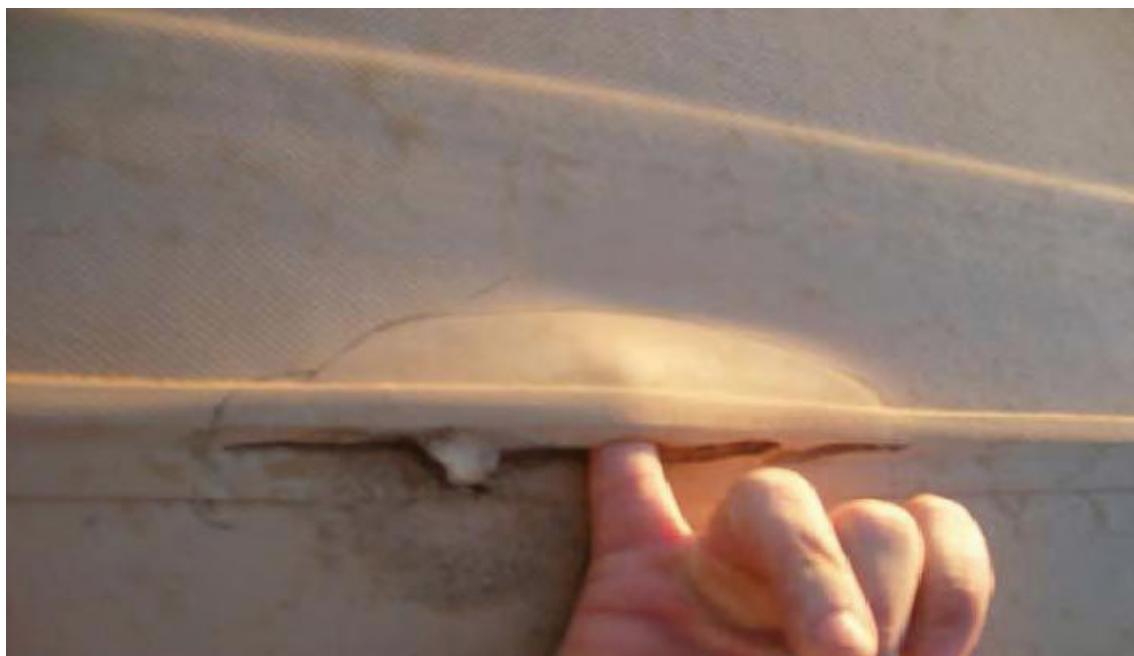
Figure 3. Fabric seams coming apart due to hydrolysis.

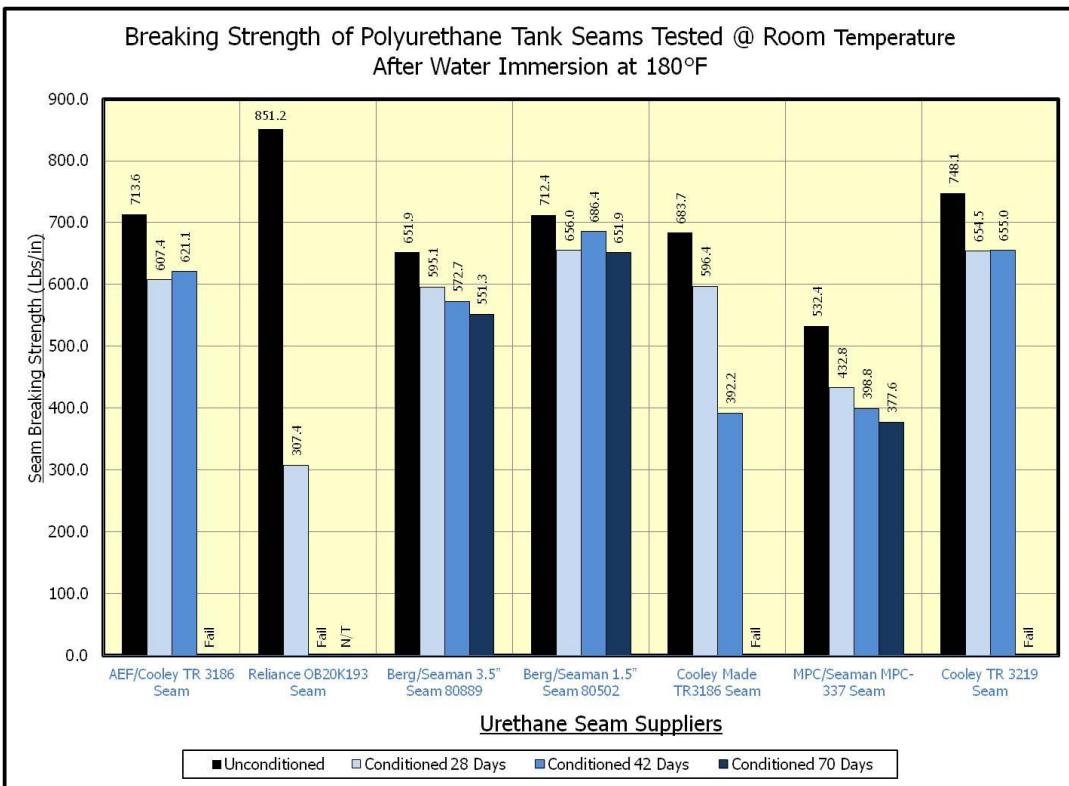
Urethane coatings are particularly susceptible to undergo hydrolysis, which is a chemical reaction with water, resulting in chemical breakdown of the urethane coating, resulting in cracking or extreme softening of the urethane polymer. Hydrolysis can be quite rapid in certain urethane systems so we evaluated the resistance to hydrolysis of these urethane-coated fabrics. Since hydrolysis of the urethane coating would not affect the strength of the base fabrics due to the nylon/polyester woven fabric, accounting for all of the composite tensile strength, it is preferable to evaluate the hydrolytic stability in the bond line where the urethane coating is fully responsible for the mechanical strength. Figures 6 and 7 compare the seam-breaking strengths measured at room temperature after water immersion at 180 °F at time increments of 28, 42, and 70 days. All materials provided adequate mechanical integrity after 28 days of immersion; however, all of the materials' seam-breaking strengths decreased with water immersion. The inside coating of this tank material became hard and brittle after the samples that had been exposed to water for 42 days and beyond, which is indicative of a failure due to hydrolysis (see figure 8). The seams made from the Cooley TR 3186 and TR 3219 materials also failed after immersion in water for 70 days at 180 °F and exhibited cracks in the interior white coating from hydrolysis caused by water immersion. This type of deterioration normally happens with ester-type urethanes. The Cooley TR 3186 material was used by Avon Engineered Fabrics in recent years to manufacture and supply fuel tanks to the military.

Figure 6. Breaking tensile strength of fabric seams after immersion in water at 180 °F.

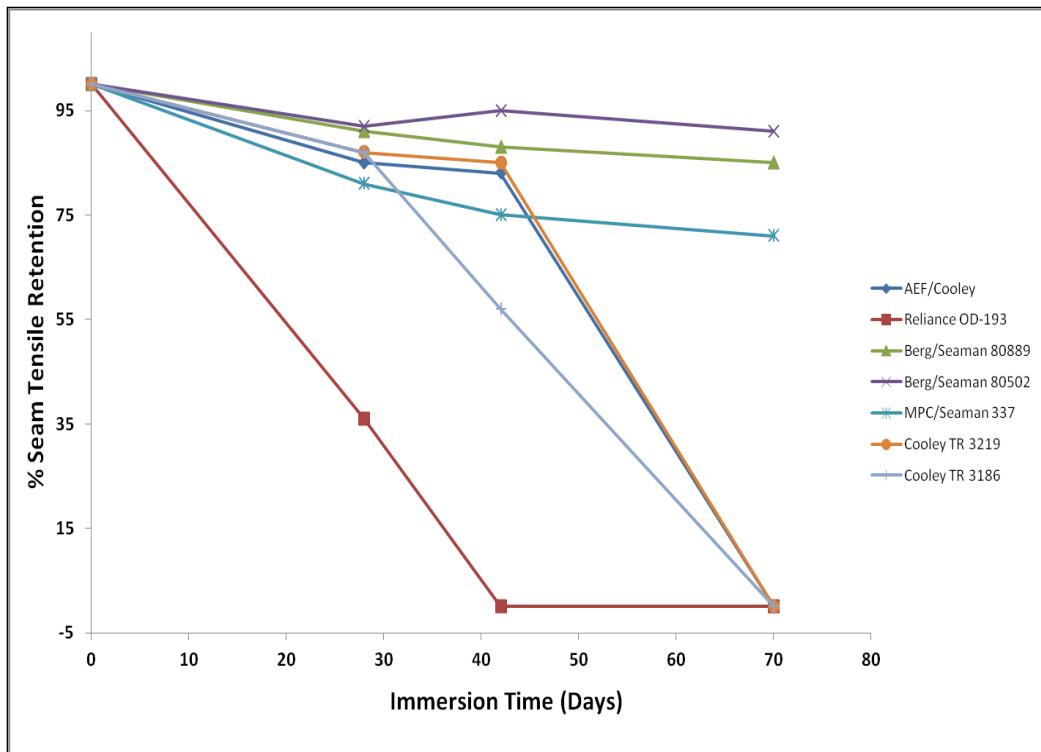
Figure 7. Seam tensile strength retention of fabric seams after immersion in water at 180 °F.

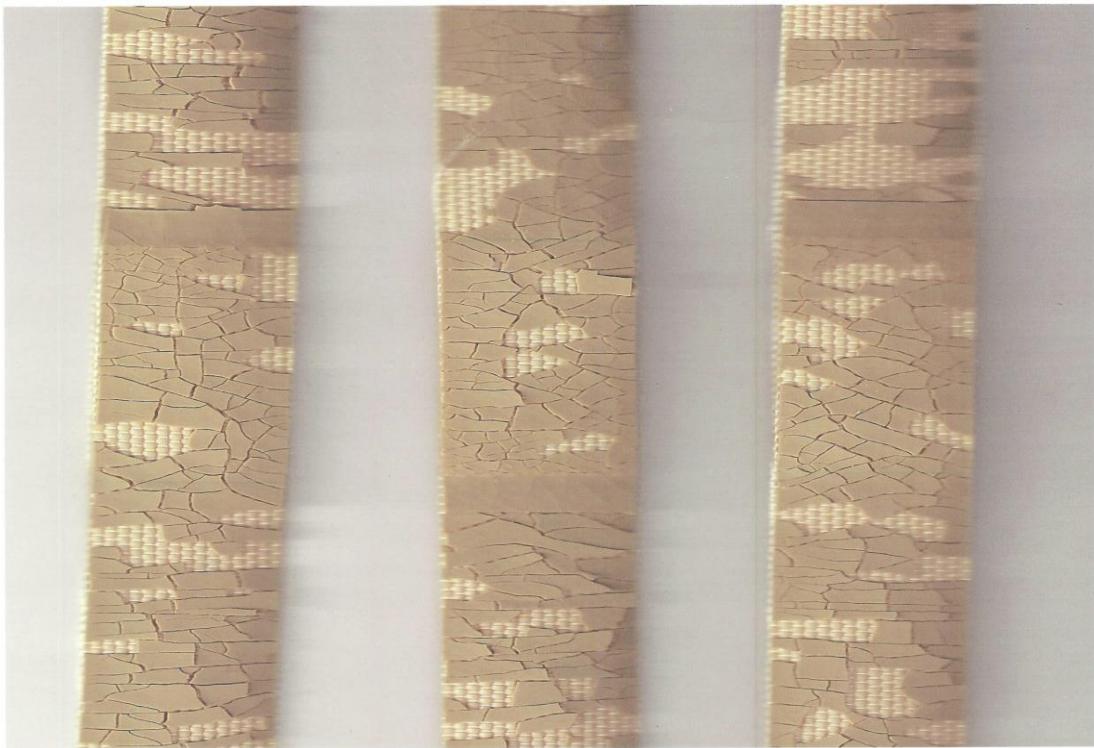
Figure 8. Reliance coated fabric after 42-day immersion showing advanced hydrolysis.

The urethanes studied in this work fall into two groups, those that underwent hydrolysis within the 72-h conditioning cycle and those that resisted hydrolysis during this time period. The polyurethane materials provided by Cooley and Reliance showed a vulnerability water attack, while all the materials provided by Seaman provided better resistance to water. The Cooley and Reliance exhibited no peel adhesion strength retention after 72 days in water at elevated temperatures, while the Seaman coated fabrics retained an average of 85% of original peel adhesion strength. It is expected that tanks made from these Cooley materials, and especially the Reliance materials, would have a shorter shelf life and service life in areas with hot, humid environments. Another problem could arise with tanks that have been used, cleaned, and returned to storage with some residual water. The picture of the Reliance-coated fabric after water immersion at 180 °F for 42 days is indicative of what the Cooley materials looked like after water immersion for 70 days at 180 °F.

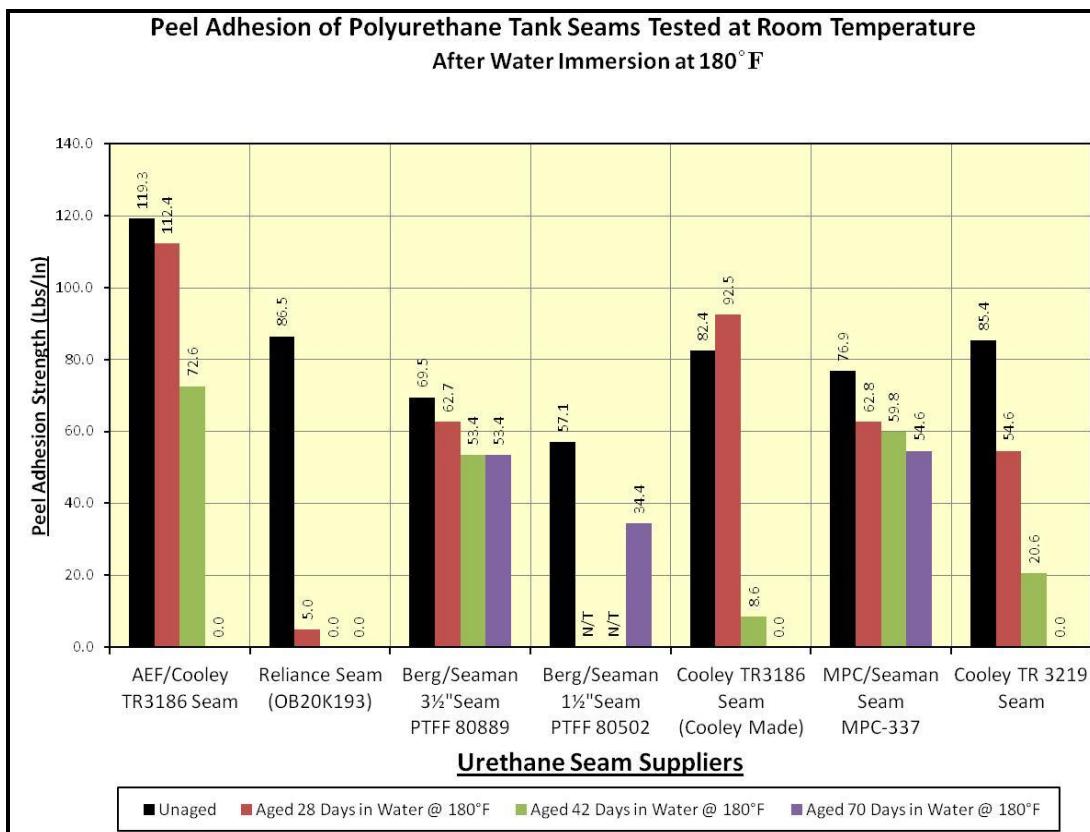
The retention rates for all seven materials studied are presented in figure 9. This graph points out the poor performance of the materials manufactured by Cooley, in that all fabrics exhibited 0% retention after being immersed for 70 days. The Reliance material, used to manufacture 20,000 fuel tanks for the military in 2002, exhibited a significant amount of deterioration after only 28 days of immersion at 180 °F. As seen in figure 9, this seam retained only 36% of its original breaking strength after 36 h. The three coated fabrics from Seaman Corporation, the Berg/Seaman 80889 (3.5-in. seam width), Berg/Seaman 80505 (1.5-in. seam width), and MPC/Seaman 337, all performed well in our testing. The Berg/Seaman 80889 and 80505 retained approximately 95% of its original seam strength while the MPC/Seaman 337 retained 75%.

Figure 9. Peel adhesion of fabric seams after immersion in water at 180 °F.

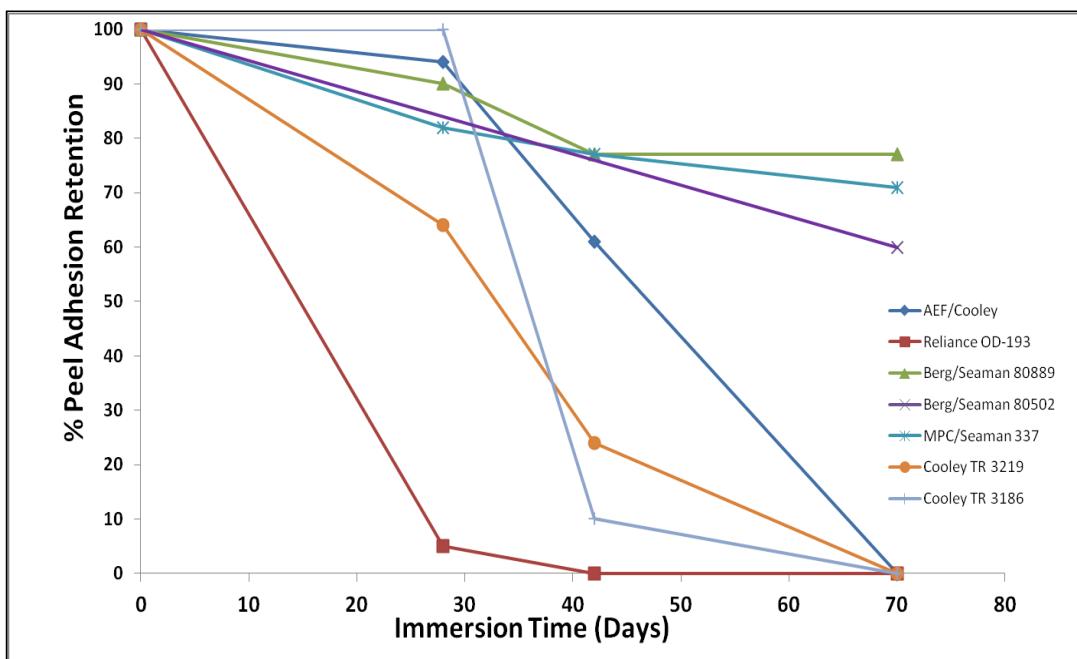
Figure 10 compares the seam peel adhesion measured at room temperature after water immersion at 180 °F for time increments of 28, 42, and 70 days. The seam peel adhesion is an excellent test method to determine the resiliency of the bond line to hydrolysis. As seen in the seam breaking strength results (figures 7 and 8), the Reliance seam performed very poorly in the peel adhesion testing. This seam failed to provide any peel adhesion strength after a 42-day water immersion cycle exhibiting significant surface cracking on the interior coating (fuel side). The seam provided a 5-lb/in. peel adhesion value after the 28-day immersion—a critical failure. All the other Cooley materials performed slightly better, though the seam structures failed the 70-day water immersion test. All the seams constructed with the Seaman fabrics performed well and provided excellent peel adhesion values even after immersion in water for 70 days at 180 °F. As with the seam tensile strengths, the Cooley and Reliance fabrics performed poorly. The Reliance fabric failed almost immediately while the Cooley fabric showed no strength retention after the 72-h immersion time. The Berg/Seaman 80889 and 80505 retained approximately 80% of its original seam strength while the MPC/Seaman 337 retained 60%.

Figure 10. Seam peel adhesion strength retention of fabric seams after immersion in water at 180 °F.

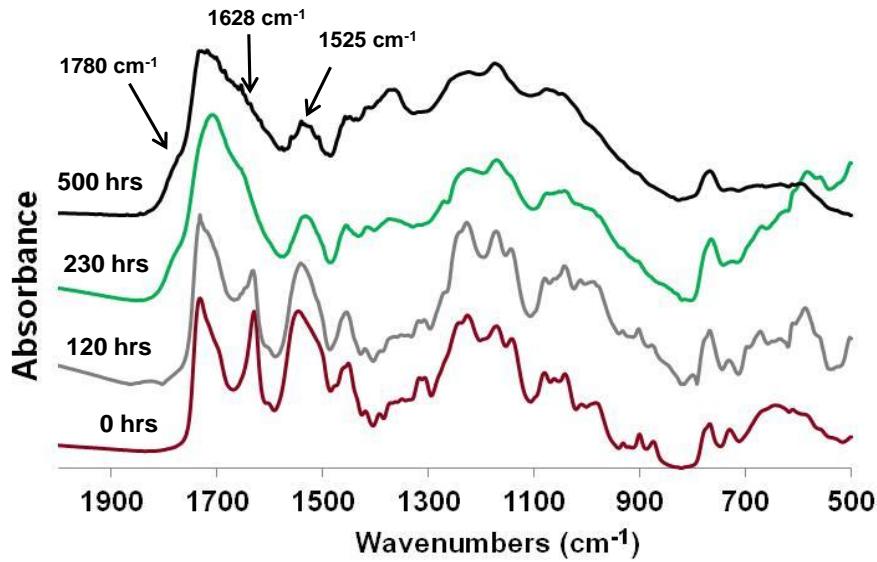
FTIR was conducted on these polymers to identify molecular changes occurring within the polymer domains. FTIR looks only at the chemical events occurring at the surface and does not yield information on the bulk polymer composite. Figure 11 shows the progression of the infrared spectra with immersion time of the Seaman coated fabric. The FTIR spectrum at 0 h show two carbonyl peaks at  $1700\text{ cm}^{-1}$  and  $1720\text{ cm}^{-1}$ , which can confidently be assigned to a hydrogen-bonded carbonyl and a nonhydrogen-bonded carbonyl (16), respectively. The  $1700\text{-cm}^{-1}$  band appears to shift to lower frequencies ending at  $1660\text{ cm}^{-1}$ . The FTIR spectra show growth of two new carbonyl peak formations at  $1778\text{ cm}^{-1}$  and  $1750\text{ cm}^{-1}$  with increasing water immersion time. The  $1778\text{ cm}^{-1}$  is due to an acidic carbonyl that results from the reaction of a urethane carbonyl and water molecule. In addition, a decrease in  $1525\text{ cm}^{-1}$  is associated with the amide II band ( $\nu(\text{C-N})$ ), and a decrease in  $1628\text{ cm}^{-1}$  is associated with the amide I band [ $\nu(\text{C=O})$ ], indicating urethane bond cleavage (17–19). These molecular groups are responsible for cross-linking the urethane chains to provide mechanical and structural integrity. While the urethane inherently contains ether groups as part of the molecular backbone, new ether groups form as evident from the widening of IR bands in the  $1300\text{- to }1000\text{-cm}^{-1}$  region. This is a result of direct insertion of OH groups into the urethane linkage.

Figure 11. Progression of FTIR spectra with immersion time in water at 180 °F.

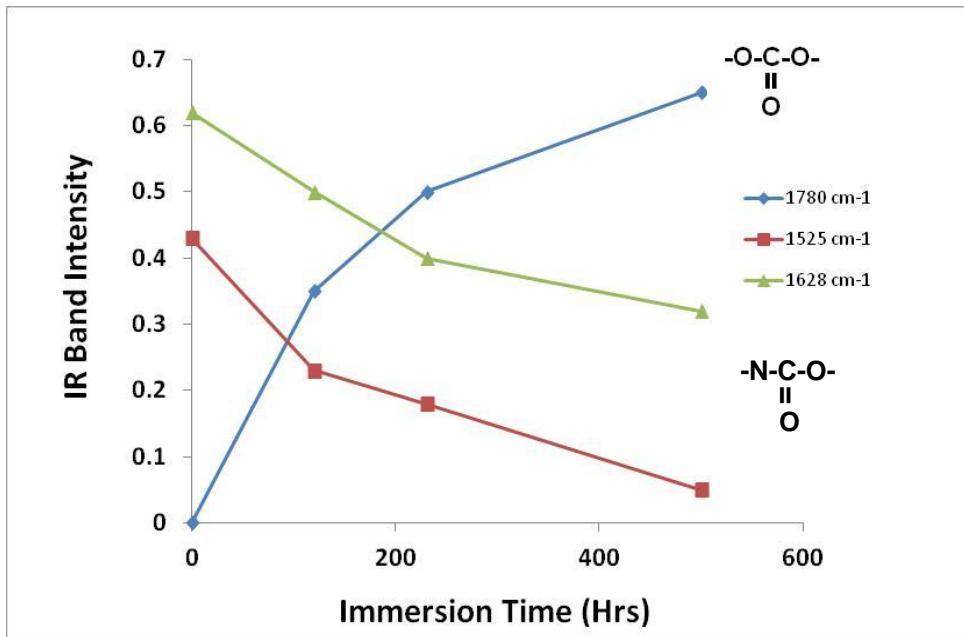
Figure 12 graphs these changes. The appearance of ether groups coincides with the decrease of the urethane links. Identical structures were identified for all seven coated fabrics studied in this report.

Figure 12. FTIR individual IR band changes with immersion time in water at 180 °F.
